# SAFETY BULLETIN

Explosion in Morley, Western Australia

Issued: 12 February 2015

| Number: 04-15

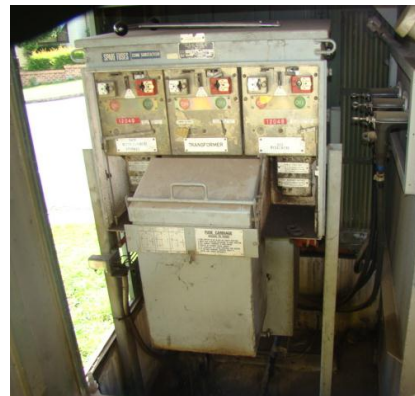
Figure 1. GEC T30F

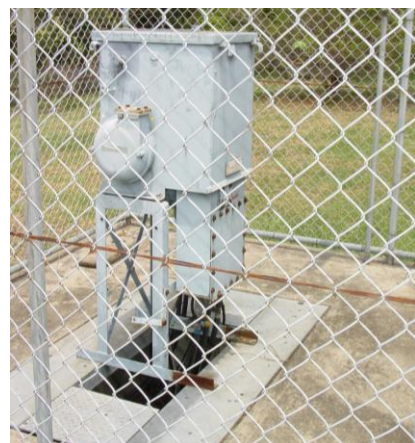
Figure 2. Long & Crawford GF3

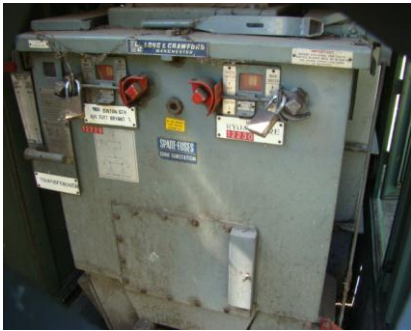
Figure 3. Long & Crawford T3 GF3

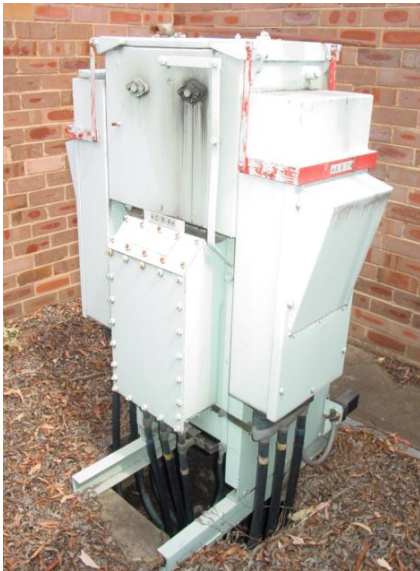
Figure 4. LUCY oil switch

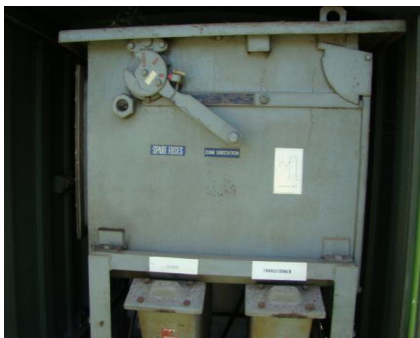
Figure 5. ALM Dulmison Oil Switch

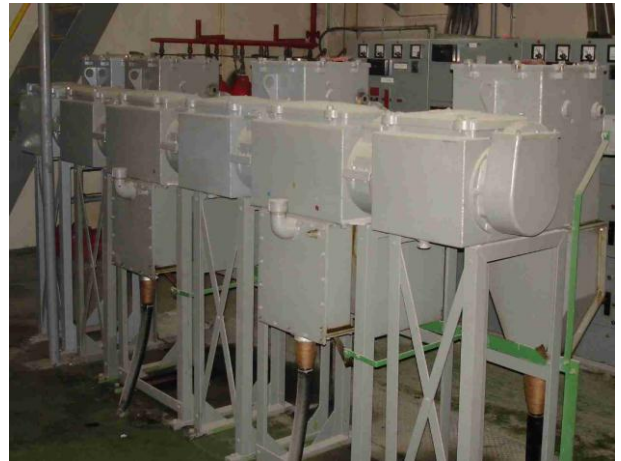
Figure 6. Statter / Mirra VL oil switch

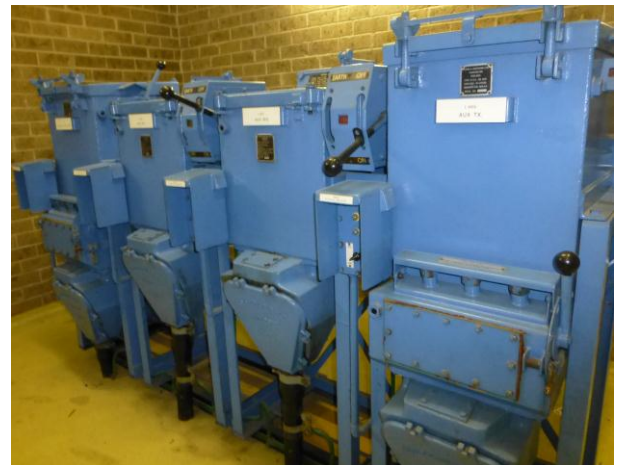
Figure 7. Long & Crawford ETV2 oil auxiliary switchgear (Carramar ZS)
